Project Name: Gold King Mine	Site Location: Silverton, San Juan County, Colorado	Project No. 0001/1408-01
--	---	------------------------------------

PHOTOGRAPH LOG

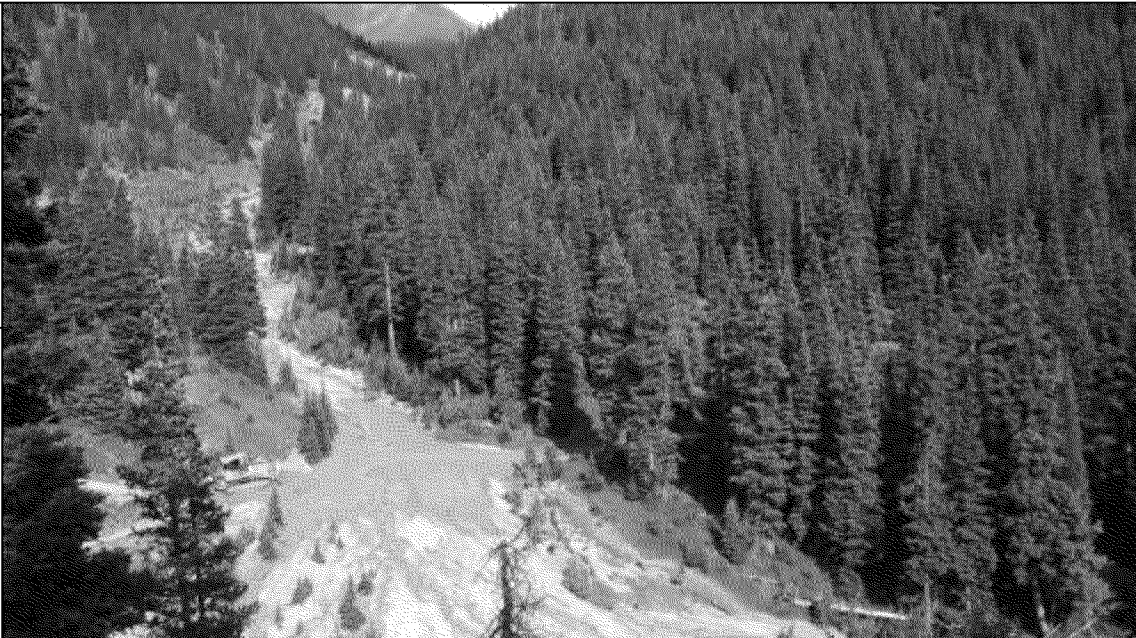
Photo No. 53	Date: 08/05/2015

Direction Photo Taken: East		
Description: Looking east across Cement Creek from County Road 10 to excavator fixing County Road 52 at North Fork crossing just south of Red and Bonita Mine.		
Photo No. 54	Date: 08/05/2015
